UPDATE: STOP USE AND RECALL NOTIFICATION IMMEDIATE ACTION REQUIRED

Subject: 3M[™] 9322A+ Respirator

3M Personal Safety now announces an immediate Stop Use and Product Recall of the 3M[™] 9322A+ respirators. Due to the lack of full adhesive application, the nose foam may separate from the top panel of the 3M[™] 9322A+ respirators. 3M has determined that affected respirators may not meet its expected performance.

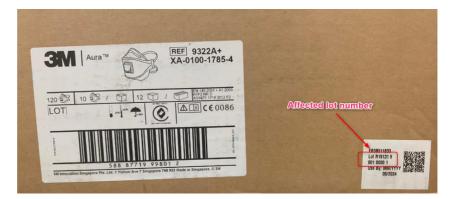
- 1. On the bottom right-hand side of the 3M shipper case label;
- 2. On the bottom left hand corner for the individual box; and
- 3. On the individual respirators

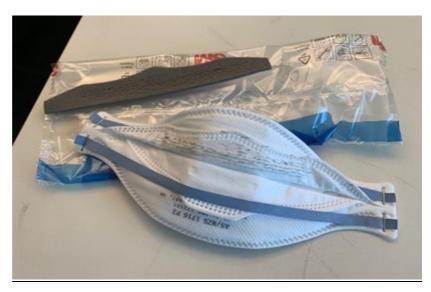
Foam separating from the top panel of respirator

If you have any of the affected products, please complete the attached "Stock Return Form" and email the form to 3M at aucsquality@mmm.com together with an image of the batch number for replacement stock of new 3M[™] 9322A+ respirators.
