## INSPECTION NOTICE IMMEDIATE ACTION REQUIRED

Subject: 3M™ PROTECTA® Rebel Self Retracting Lifelines (CE Versions)

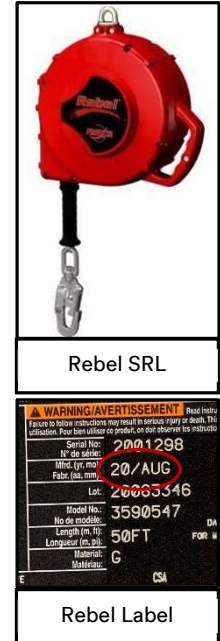
Step 1: Locate the label on the Rebel SRL to identify the manufactured date (see picture to the right). If the SRL has a manufacture date of 19/10 (October 2019) through to the end of 20/02 (February 2020), continue to step 2. (Please note that regardless of the manufacture date, all SRLs should be inspected before and after use and by a height safety equipment inspector every 6 months as per the AS/NZS 1891.4).

Step 2: Pull the lifeline quickly to ensure that the SRL locks up. As per the IFU “Ensure the device locks up when the lifeline is jerked sharply. Lockup should be positive with no slipping.” If the SRL locks up properly and passes all other aspects of the pre-use inspection as defined in the IFU, the SRL is acceptable for use. If you find that your SRL does not lock up, take the Protecta® Rebel SRL out of service immediately. Please contact our Customer Service department at 1800 245 002 or email us at [3msupport.safety.au@mmm.com](mailto:3msupport.safety.au@mmm.com) and we will arrange to have the SRL inspected and repaired/replaced as per our standard warranty.
